**Flood Control Project Maintenance
Levee Inspections**
LMA District Cover Sheet
Spring 2019 Levee Inspection Results

Reclamation District No. 0544 Upper Roberts Island

Waterway			Bank	Unit Miles
Unit No. 01 San Joaquin River			Left	6.05
	Spring (March - May)	Summer (June - August)	(September - November) Fall	Winter (December - February)
Unit Maintenance Rating (Fall Only)				
Date of Inspection	5/9/2019 - 5/9/2019			
DWR Inspector	Alberto De Leon			
Accompanied By	Jerry Robinson

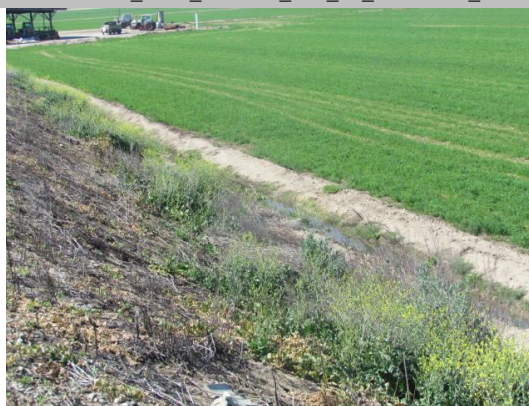
Photo 1 of 1 : SP_2019_RD0544_108_85_20190313_00055.jpg

Looking southwest at Irrigation ditch at landward toe.

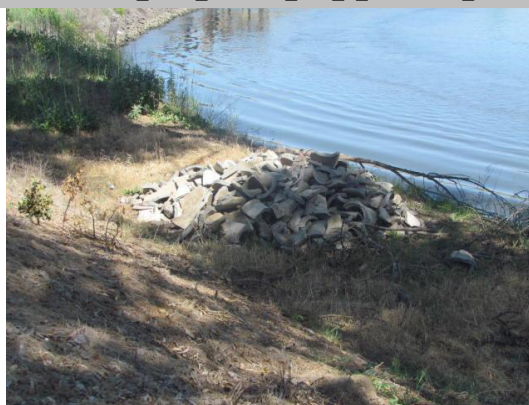
Photo 1 of 1 : SP_2019_RD0544_108_1_20190313_00001.jpg

LM Start	0.45	Rating **	M	Issue No.	1
LM End	0.45	Issue Type +	En	Location *	WS
Category	Earthen Levee			GPS Latitude/Longitude	
				Start	End
Item	Encroachments			37.864713 °	37.864713 °
				-121.326708 °	-121.326708 °
DWR ID	DWR_RD0544_01_f_2013_1				
Comment Code					
MA : Material					
Inspector Comment					
Old broken concrete pipes were placed on the waterside berm.

Looking northeast at broken concrete piping on waterward berm.

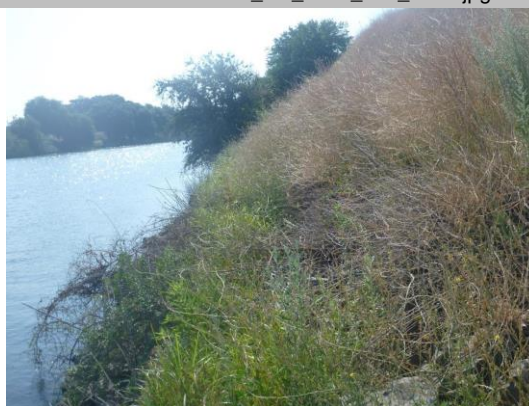
Photo 2 of 3 : LEVAL_SP_2019_571_4480.jpg

LM Start	0.64	Rating **	A/W	Issue No.	75 (cont)	
LM End	0.64	Issue Type +	Ma	Location *		
Category	Supplemental			GPS Latitude/Longitude		
				Start		End
Item	2017 Storm Damage			37.863900 °		37.863900 °
				-121.323500 °		-121.323400 °
DWR ID	DWR_RD0544_01_f_2017_75					
Comment Code						
Inspector Comment						
Levee Evaluation Comments						
Description:Slope protection repairs are needed along the waterside slope due to erosion and riprap displacement from high water. Based upon levee inspections, it was determined the waterside levee slope is eroding, deteriorating, and degrading. The eroded levee sections need to be restored back to design standards to prevent further deterioration and damage.						
Site ID No:571						
Site Designation:LMA-477						
Repair Type: Erosion						
Rating:Area of Concern						
Field Date:8/10/2017						
Notes:

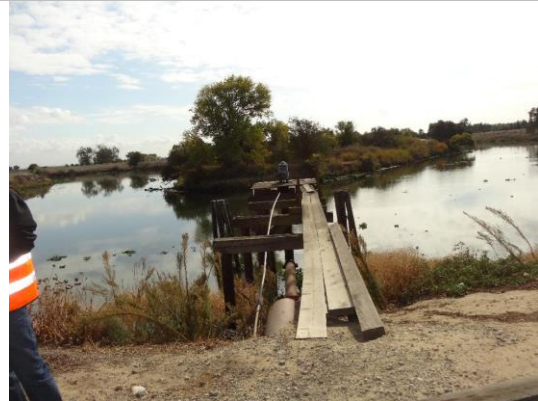
Photo 3 of 3 : UCIP_SP_2019_51351_41784.jpg

WS view: depression on levee shoulder near walkway. Half of the walkway stripped off.

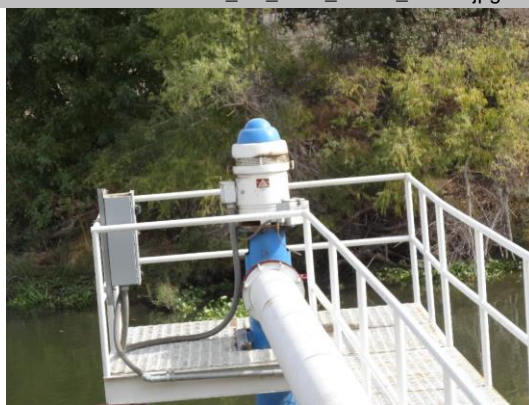
Photo 2 of 3 : UCIP_SP_2019_53362_42006.jpg

WS view: steel pipe, walkway to the pump, and pump on steel pile structure in the stream.

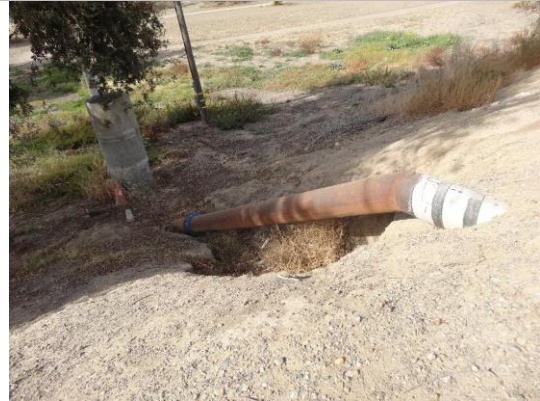
Photo 3 of 3 : UCIP_SP_2019_53362_42005.jpg

LS view: exposed pipe, concrete standpipe (left), service pole (top right) and eroded slope.

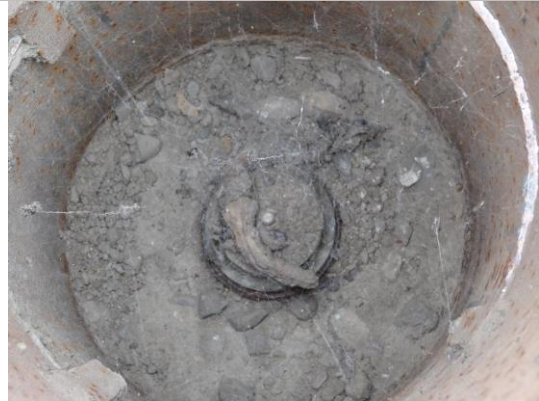
Photo 3 of 3 : UCIP_SP_2019_53363_44828.jpg

WS view: siphon breaker inside steel pipe riser on levee slope. Needs dirt cleaning/clearing.

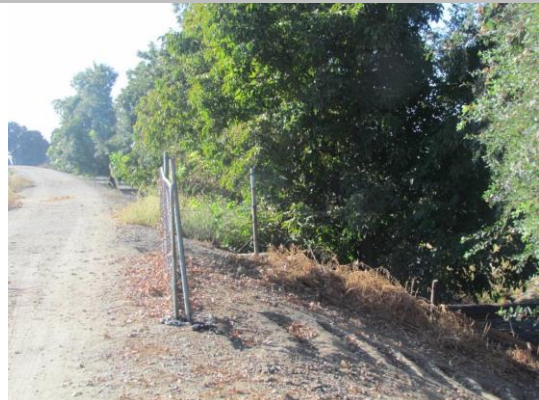
Photo 1 of 1 : SP_2019_RD0544_108_98_20190313_00063.jpg

Looking south at untrimmed trees on landward slope.

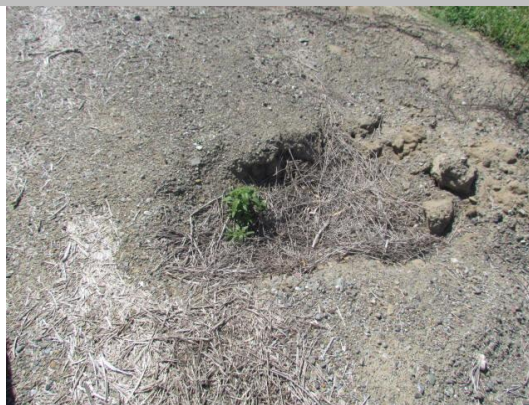
Photo 2 of 2 : SP_2019_RD0544_108_107_20190313_00068.jpg

Looking west at depression on landward shoulder.

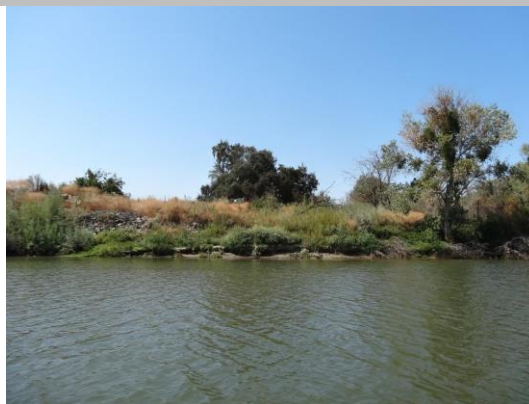
Photo 2 of 3 : SP_2019_RD0544_108_5_20190313_00011.jpg

Front view of the erosion.

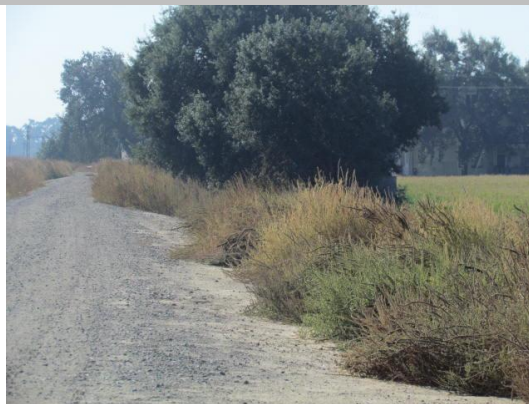
Photo 1 of 1 : SP_2019_RD0544_108_47_20190313_00036.jpg

Looking south at dense veg on landward slope, Fall 2015.

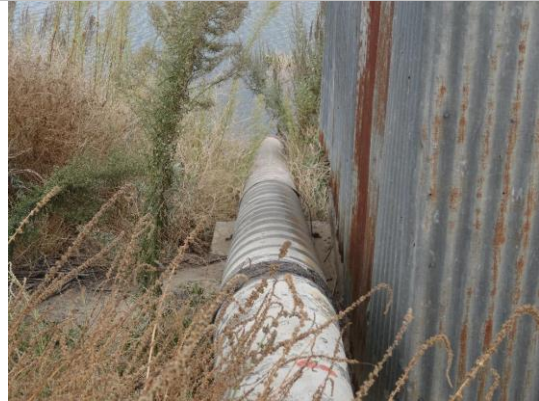
Photo 3 of 3 : UCIP_SP_2019_51365_42205.jpg

WS view: exposed steel pipe immersed into the stream. No pump attached.

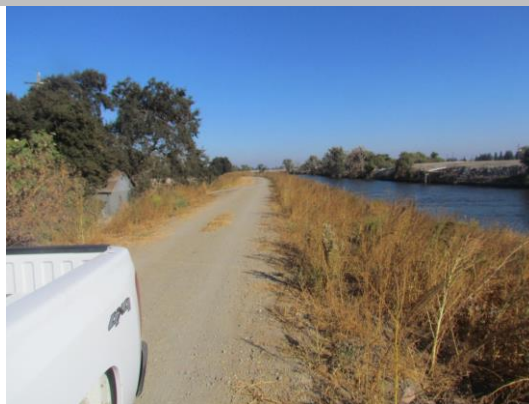
Photo 1 of 1 : SP_2019_RD0544_108_49_20190313_00038.jpg

Looking northeast at dense veg on waterward slope.

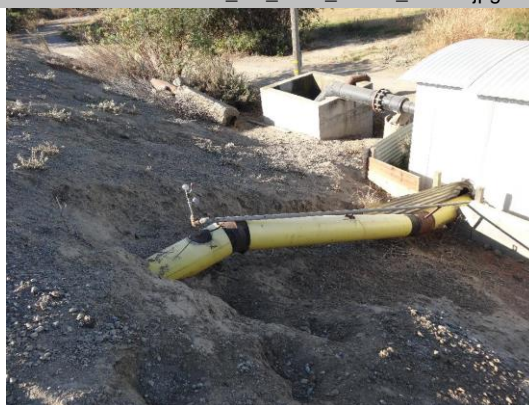
Photo 3 of 3 : UCIP_SP_2019_53364_44862.jpg

LS view: distribution box (top-left), pumphouse (right) and exposed leaky pipe on eroded levee slope.

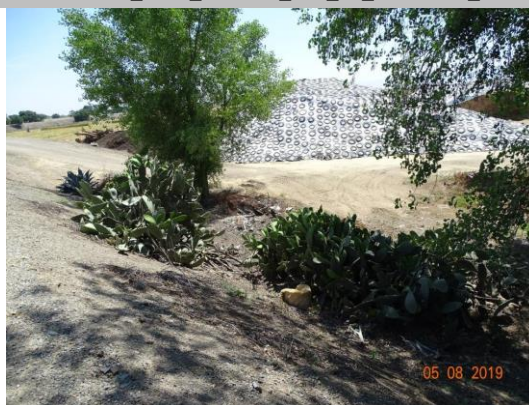
Photo 1 of 1 : SP_2019_RD0544_108_94_20190523_00172.jpg

View of cactus on landside slope. (Spring 2019)

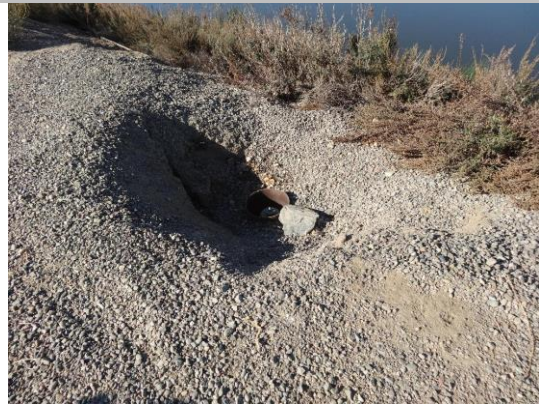
Photo 1 of 3 : UCIP_SP_2019_53366_44882.jpg

WS view: depression on levee slope around siphon breaker.

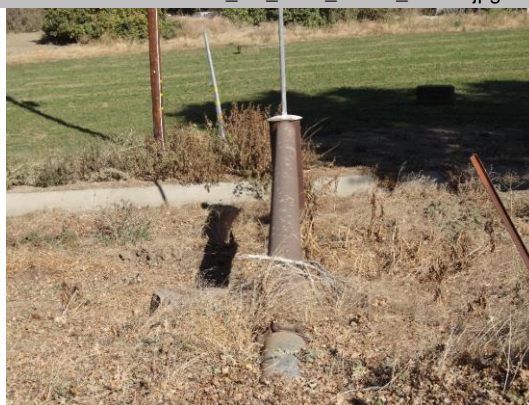
LS view: exposed steel pipe and air vent on levee berm. No pump found.

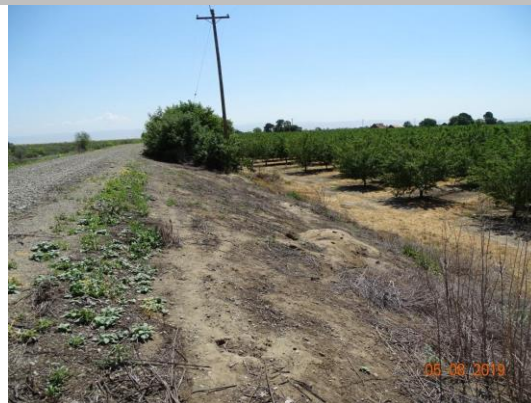
View of landside slope with multiple animal burrows. (Spring 2019)

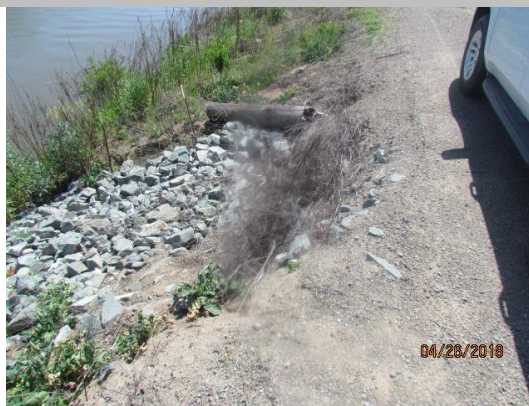
Looking south at erosion on shoulder. (Spring 2018)

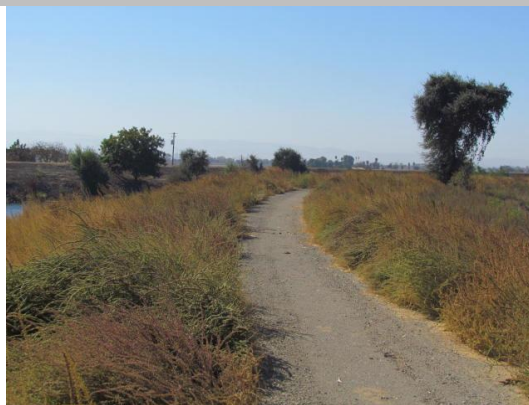
Looking at dense vegetation on landward and waterward slope.

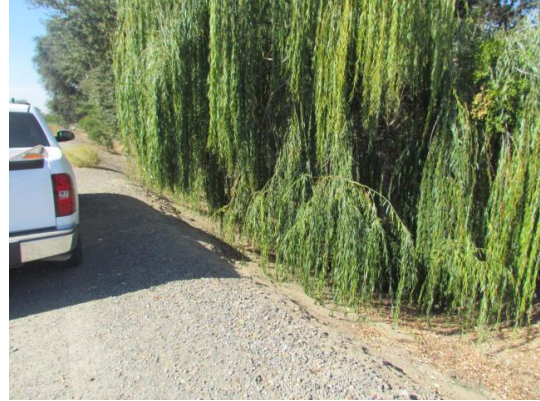
Looking southwest at untrimmed trees on landward slope and toe, Fall 2015.

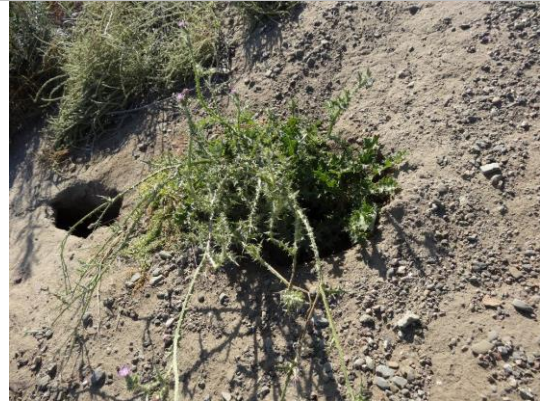
WS view: levee slope with pits and holes.

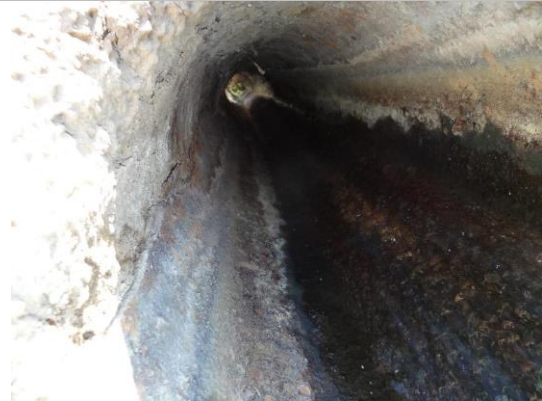
WS view: inside view of hole in deteriorated pipe.
